Failure Mechanisms in Integrated Circuits

Seshu V. Pabbisetty, Dan Corum, P. Scott, and Kendall Scott Wills
Texas Instruments, Semiconductor Group
Stafford, Texas

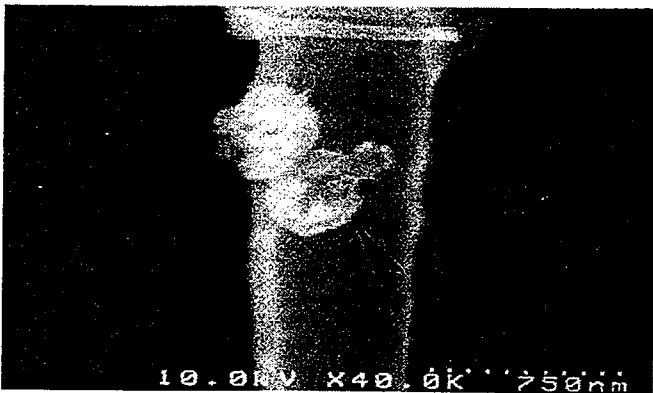
Foreign Particles. Foreign particles can typically be traced to process equipment and personnel. Fig. 1 shows a DRAM device, which showed a column failure. Using the electrical signature, the failure was traced to gate oxide particles measuring approximately 0.4 μ m, which created a leakage path at the p-channel pull-up transistor of the failing sense amplifier. The fail mechanism of this device was determined to be particulate contamination (possibly residual nitride) before gate oxidation. Similar examples of particulate contamination are shown in Figures 2 and 3.

Fig. 1. Particulate gate oxide contamination.

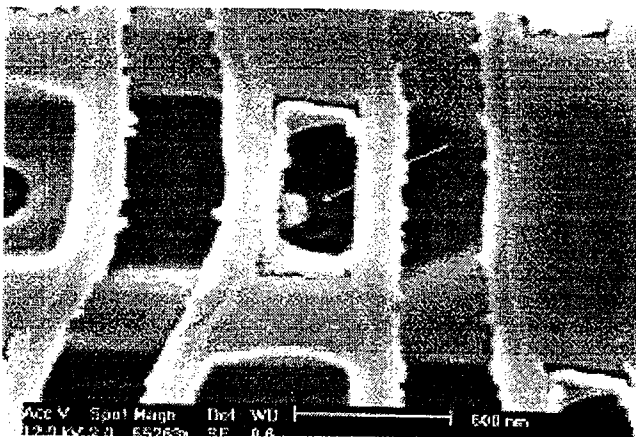
Fig. 2. Storage node contact particle

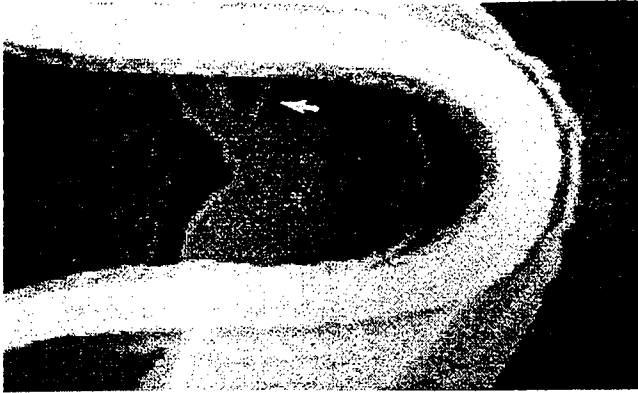
Pinholes. Many common failure mechanisms are related to the integrity of various dielectrics within the device. Defects in gate oxides can cause them to become leaky or shorted when a voltage is applied. Pinholes can be introduced during lithography steps or can arise from particulates into the area. They can also occur due to crystalline defects. With the complexity and size of today's devices, it is becoming evermore challenging to spot these kind of gate shorts visually. Even if a particulate does not produce a discernable hole, it can produce a region which has a lower breakdown strength than the rest of the oxide. Fig. 5 shows a DRAM device exhibiting a single bit logic failure. In this case, the gate oxide pinhole provided a leakage path from the word line to the cell bitline / cell capacitor. The root

cause of the failure was determined to be dielectric failure in the cell transfer gate associated with contamination (most likely residual nitride) before gate oxidation.

Fig. 5. Gate oxide pinhole providing a leakage path from the word line to the cell bitline / cell capacitor.

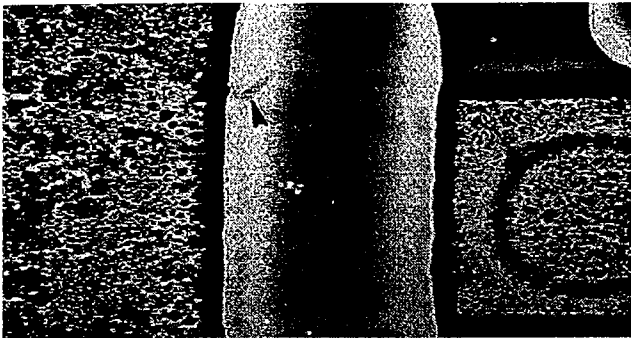
Figures 6 and 7 show other examples of gate oxide pinholes. In Fig. 6, the gate oxide pinhole provides a leakage path from Vpp to the passing word line in the row decoder causing this row to be "stuck on." The root cause was determined to be dielectric breakdown due to gate oxide thinning at the field oxide edge (birds beak).

Fig. 6. Gate oxide pinhole providing a leakage path from Vpp to the passing word line in the row decoder.

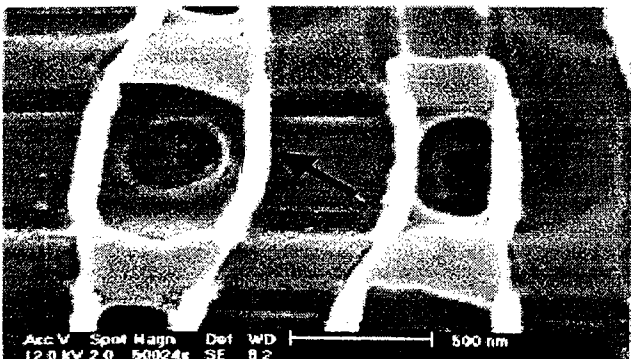
Fig. 7. Gate oxide pinhole in transfer gate.

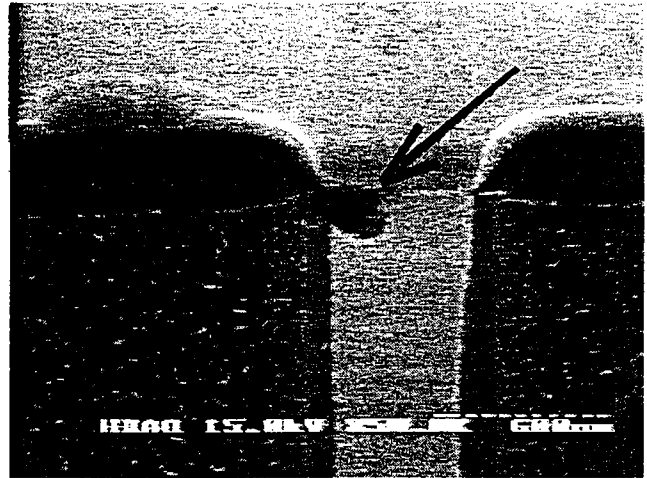
Fig. 8. Gate oxide breakdown due to EOS/ESD.

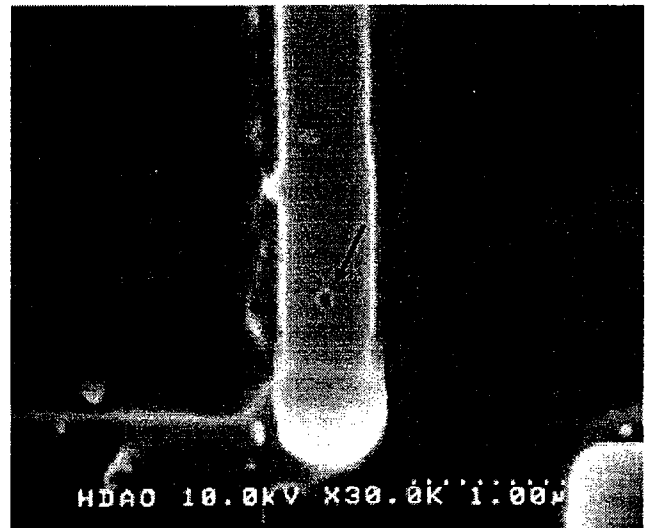
Fig. 9. EPROM device which showed multiple failing rows. After failsite isolation using emission microscopy, the failure was traced to a dielectric breakdown caused by electrical overstress.

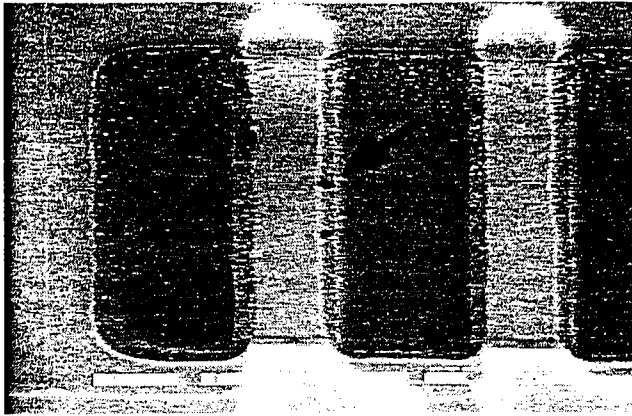
Fig. 10. Gate oxide breakdown caused by EOS/ESD.

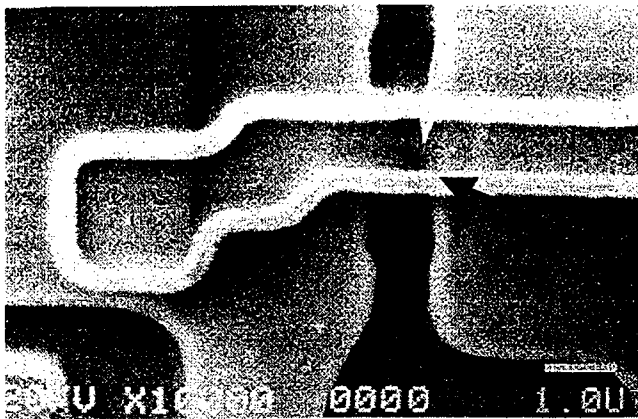
Fig. 11. DRAM cell which exhibited input leakage. After failsite isolation by emission microscopy, the defect was traced to oxide breakdown at the guard ring causing Vcc leakage. The root cause was a dielectric fail caused by the contamination of buried N+ oxide (most likely residual photoresist and nitride) before BN+ oxidation.

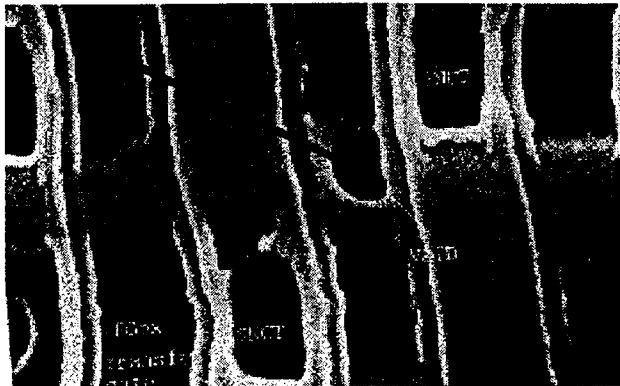
Etching Induced Damage. Other oxide related issues can also arise from processing. Fig. 12 shows an etch pit caused during an etching process.

Fig. 12. Field oxide etch pit caused by stacked cell process.

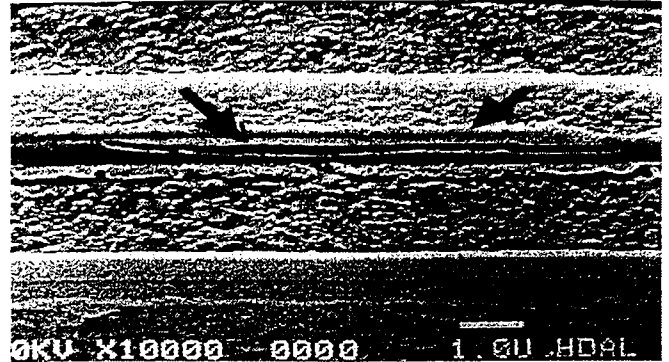
Cracking. In Fig. 13, a DRAM device is shown which failed board level final tests. Failsite isolation by liquid crystal analysis traced the defect to side wall oxide crack which caused low BVDSS (breakdown voltage drain to source) at the field plate diode ESD structure. The root cause was determined to be poor oxide adhesion of side wall as a result of polymer residue left behind after poly gate etch.

Fig. 13. Side wall oxide crack resulting in low drain to source breakdown voltage.

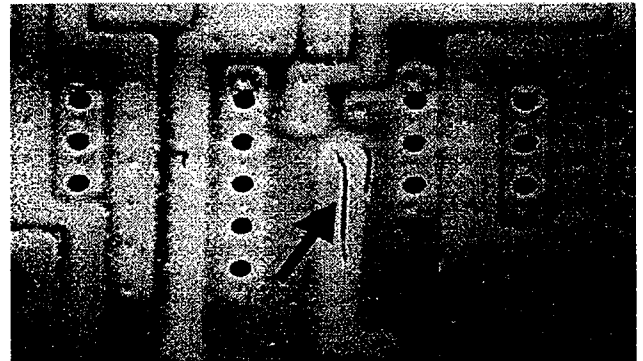
Cracking. Fig. 14 shows a DRAM device which failed due to Icc power down and block failures. After liquid crystal analysis, the defect was discovered to be an interlayer oxide crack. The failure mechanism for this device was metal two to metal one leakage in the row decoder logic as a result of a metal inter layer oxide crack. The root cause was determined to be an abnormally thin MILO2 layer that was unable to compensate for the high tensile stress of the MILO1 layer.

Fig. 14. Metal inter-layer oxide crack causing metal two to metal one leakage.

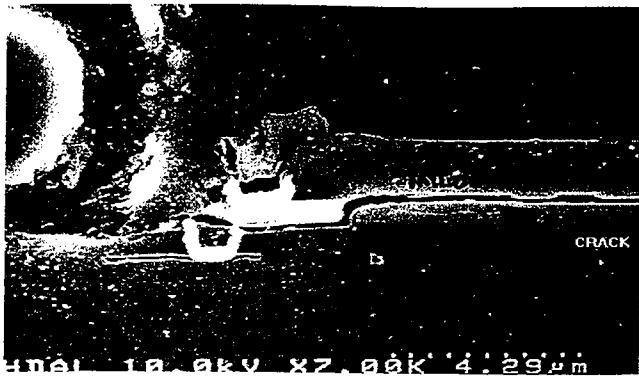
Delamination. Delamination is also a concern in oxide layers. Fig. 15 shows a DRAM device which exhibited patterned array block failures. Visual analysis revealed that the gross functional failure was due to open metal lines associated with metal inter layer oxide delamination and corrosion. The root cause was determined to be moisture penetration and package stress which resulted in metal inter level oxide delamination. Poor adhesion between metal inter level oxide (MILO) and multi layer oxide (MLO) was also a contributing factor.

Fig. 15. Metal inter layer oxide delamination due to moisture penetration and package stress.

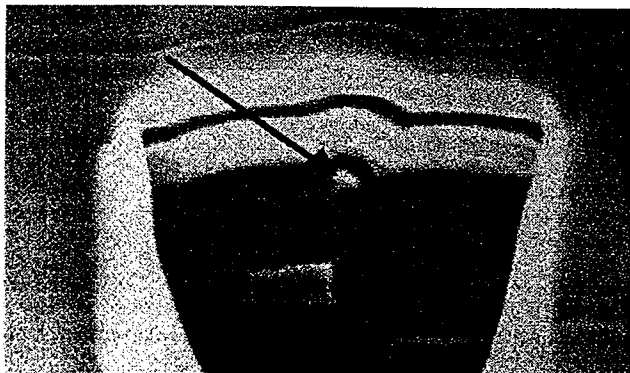
Particulates. Oxide layers are also susceptible to particulate contamination. In Fig. 16, a DRAM device is shown which exhibited shorts. After failsite isolation by liquid crystal analysis, the defect was traced to a particulate contaminate which can be seen at the metal interlayer oxide level after being cross sectioned using a Focused Ion Beam (FIB) workstation. The fail mechanism for this device was a metal interlayer oxide particle measuring approximately 0.5um which provided a leakage path between metal 3 and metal 2 in the device circuitry. The root cause for this mechanism was determined to be dielectric failure caused by particulate contamination prior to metal three lithography. Energy dispersive x-ray (EDX) analysis of the particle revealed calcium, potassium and chlorine.

Fig. 16. Particulate contaminate in the metal interlayer oxide.

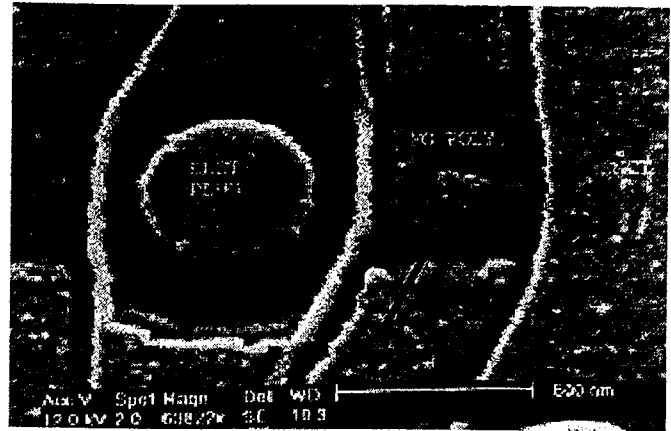
Fig. 17. DRAM device which was deprocessed to poly level using lapping techniques. The arrow indicates a poly particle which should not be there.

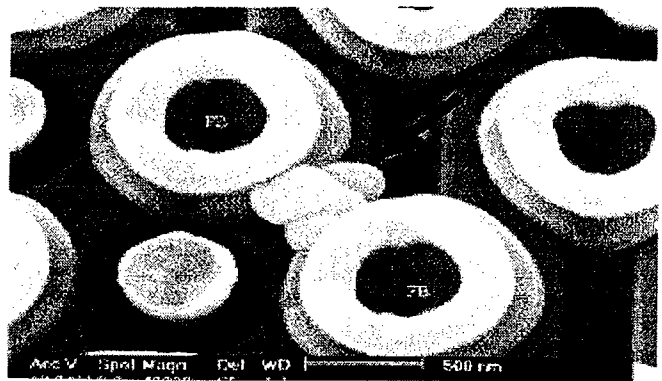
Fig. 18. Contamination of a storage cell (poly two level)

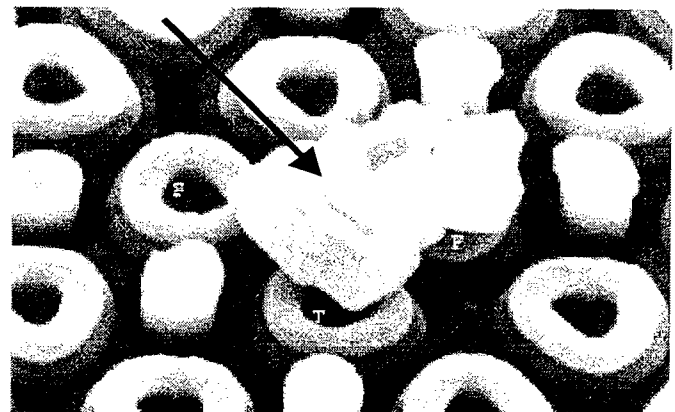
Fig. 19. Particle on top of poly plate

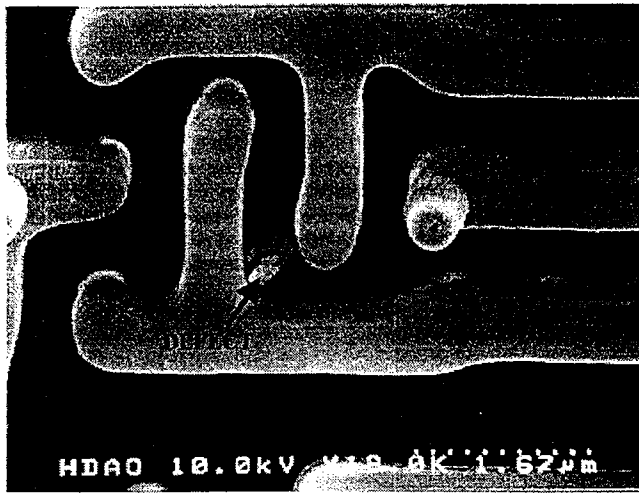
Particulates. Figures 20 through 22 show examples of metal layer particulate contamination. Fig. 20 shows an example of metal particulate contamination at the metal one layer. Fig. 21 shows a an FIB cross section illustrating particulate contamination under the metal one layer resulting in degradation of the metal layer. Elemental analysis of the particle revealed the presence of titanium, which caused leakage and subsequent functional failure. Steep dielectric steps create metallization problems such as metal bridging and metal opens. Fig. 22 shows a particulate contamination at the pre-ONO layer.

Fig. 20. Metal particulate contamination at metal one layer.

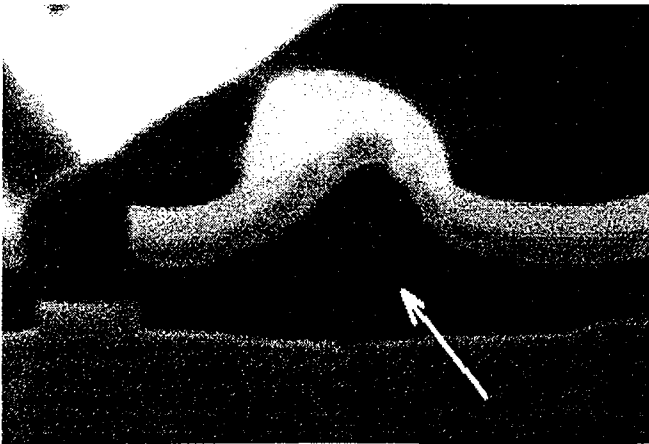
Fig. 21. FIB image revealing metal layer degradation due to particulate contamination.

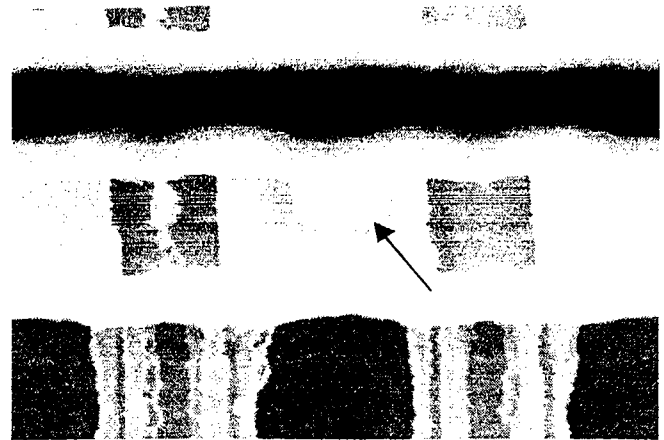
Fig. 22. Metal particulate contamination at pre-ONO layer.

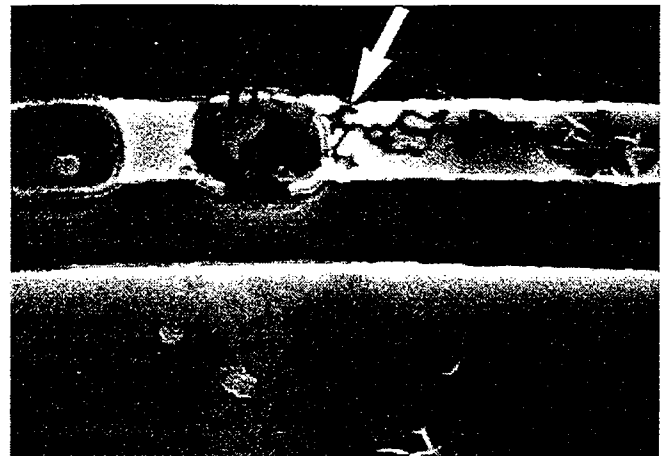
Electromigration. Opens in metal lines due to electromigration occur as thin films are stressed at high current densities. This causes the metal atoms themselves to diffuse in the direction of electron travel and any flux divergence leads to a void or a pileup. Electromigration is a cumulative effect as stresses of short duration will eventually have the effect of a stress of long duration. Fig. 23 shows a DRAM device which failed a field functional array test. Visual analysis revealed an open metal in the clock circuitry as a result of electromigration. The root cause of the failure was determined to be electromigration of the Al:Si metalization due to extended high temperature / high current conditions.

Fig. 23. Open metal due to electromigration

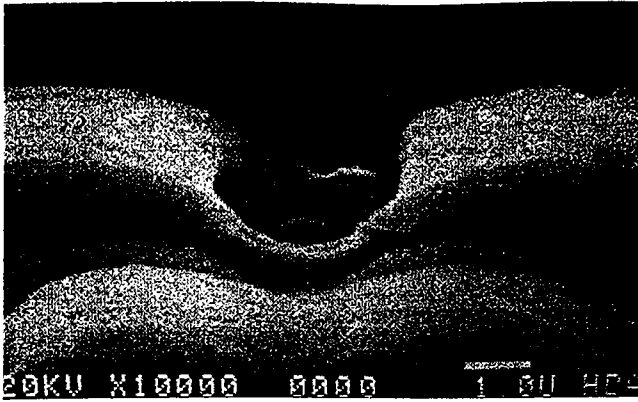
Stress Induced Failures. Fig. 24 shows a DRAM device which exhibited a partial column failure. In this case, the compressive stress of the nitride passivation was determined to be very high. The failure mechanism was an open metal bit line at the failing column due to metal voiding. The root cause was determined to be Al:Si metalization "creep" caused by high compressive stress of the overlying nitride passivation.

Fig. 24. Open metal at failing bit column due to metal voiding.

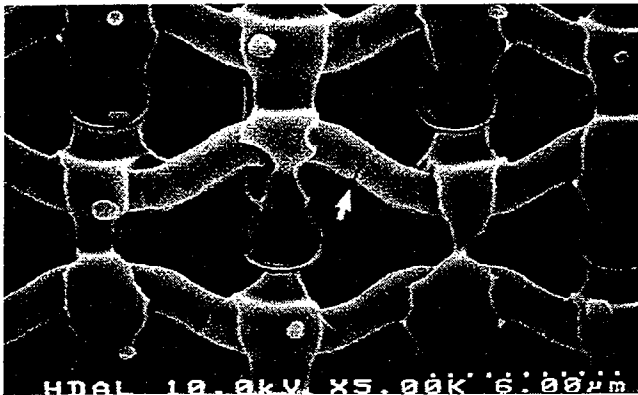
Breadloafing. PO contamination failures consist of those failures originating from particles or residue. Problems can also arise from PO coverage issues. Fig. 25 shows a poly level defect which was the result of a PO process. The image shows an EPROM device which exhibited a single bit data retention failure. After failsite isolation based on the electrical signature, the device was found to have a crack caused by poor PO coverage ("breadloafing"). The failure mechanism was determined to be a charge loss at the failing cell due to an MLO, poly 2, and ILO crack. The root cause was then determined to be that the MLO most probably originated at the PO layer as a result of PO breadloafing.

Fig. 25. Results of poor PO coverage seen at poly level.

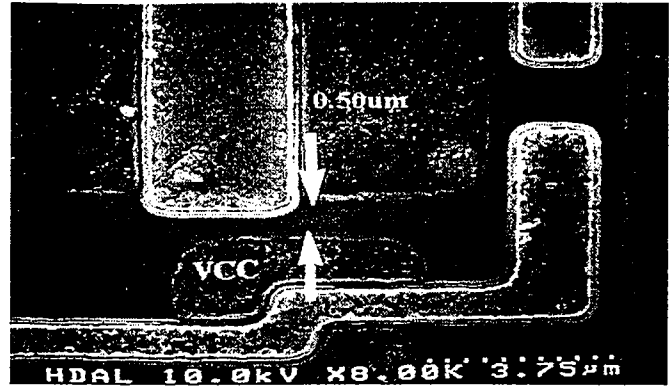
Fig. 26 shows a DRAM device which exhibited moat to moat leakage in the internal logic circuitry. Comparison of this unit to a control unit revealed a narrow moat-to-moat spacing. The control unit had a 1.1 μm spacing whereas the failing one had a .50 μm spacing. The root cause of this

failure was determined to be improper moat sizing during patterning.

Fig. 26. Moat to moat leakage due to improper moat sizing.

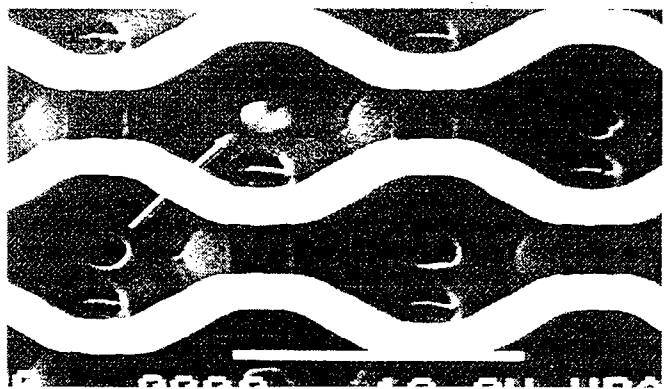
Nodules. Silicon nodules occur when Al:Si metal is deposited into a contact via and is allowed to slowly cool. As the temperature drops, so does the solid solubility of the Si in the Al, and the result is the precipitation of Si onto the outside of the metal. This undoped silicon raises the resistance of the contact substantially. An example of silicon nodule resistance is seen in Figure 27.

Fig. 27. Silicon nodule causing open/resistive poly plug/metal one contact.

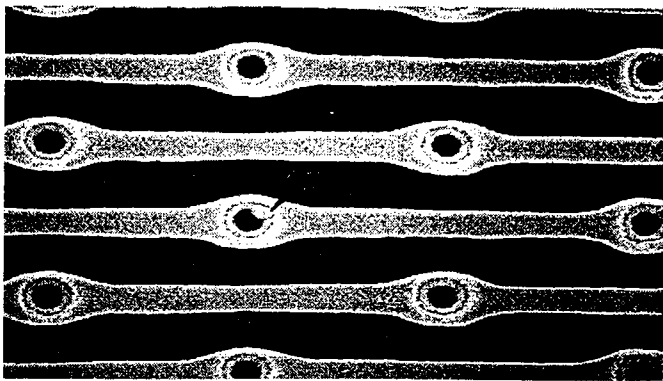
Contamination. Localized particulate contamination can also prevent complete contact etching and the proper filling of the via. Figures 28 and 29 show examples of incomplete metal deposition within the contact via. The root cause of these failures was determined to be incomplete metal step coverage as a result of contamination prior to metal

Fig. 29. Open/resistive bit line contact common to the failing bits as a result of particulate contamination.

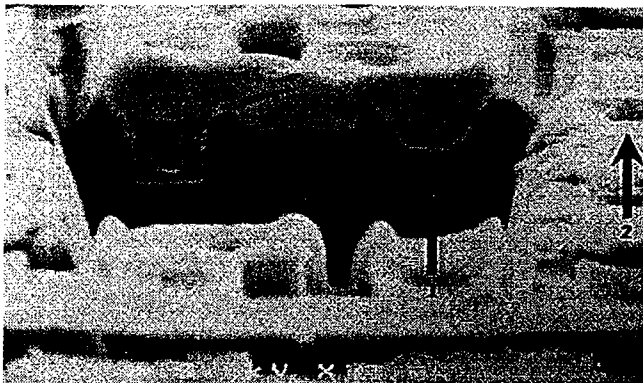
deposition. Fig. 30 shows an example of incomplete etching during contact formation. In this case, the two step contact etch process only succeeded in performing one step at the failing contact. The root cause was most likely contamination related.

Fig. 30. FIB cross section of an SRAM device which revealed an incomplete oxide etch leading to an open metal to the moat contact at the failing RAM cell.

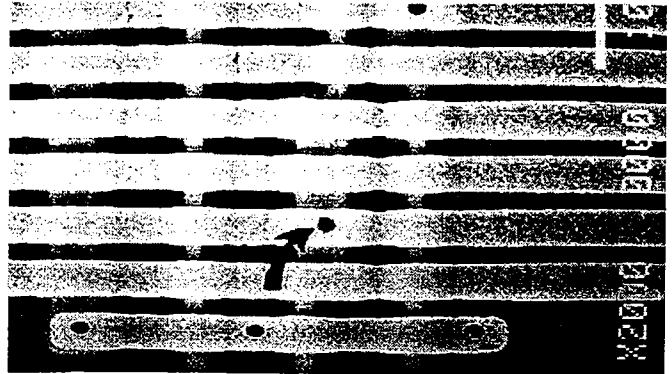
Stress Induced Failures. In many cases, a void in a metal trace can occur due to stress from an overlying passivation layer. This stress may be thermal mechanical, caused by the differing coefficients of expansions of the metal and the passivation. The compressive stress of the passivation can also be a factor. Fig. 31 shows a EPROM device which underwent failsite isolation by voltage contrast. It was determined that the row address line was disconnected from the nand gate control circuitry in row decoder as a result of open metal to poly contact. The root cause of the failure was determined to be an open contact caused by Al:Si voiding resulting from excessive compressive stress of the oxynitride passivation.

Fig. 31. Open contact due to compressive stress of overlying passivation.

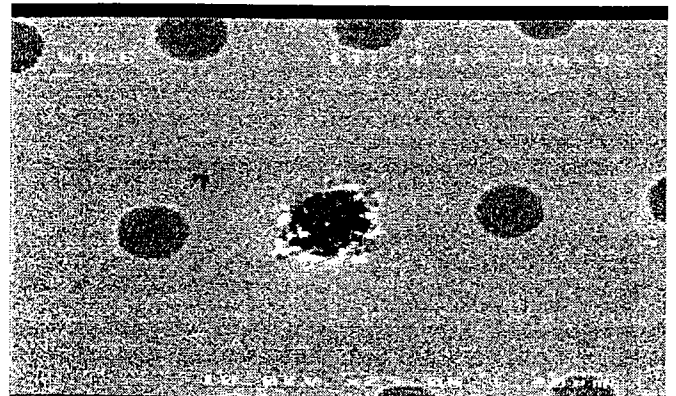
Shorted contacts are usually associated with electrical overstress (EOS) or electrostatic discharge damage (ESD). The example shown in Fig. 32 shows a blown contact due to spiking. Contact spiking can occur in Al:Si metal systems when the silicon content is low or when the sintering temperature is too high. Contact spiking can also occur during deprocessing if hot chucks are used above 450 degrees Celsius. Spiked contacts are similar to blown contacts but generally are characterized by tiny pits in the contact.

Fig. 32. Blown contact due to spiking.

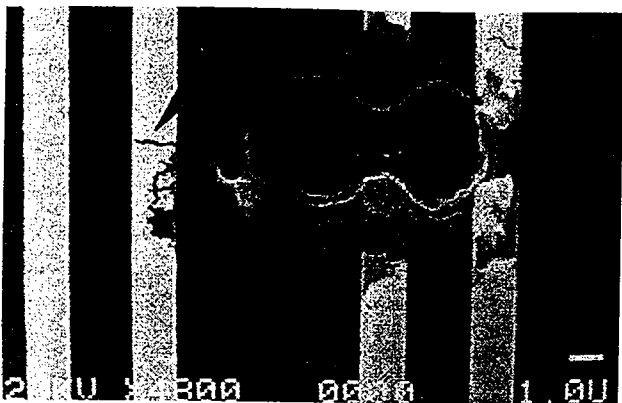
Laser repair defects have become more common as more devices use redundancy in memory arrays. The laser fuses are usually polysilicon lines that are fused open with a pulse to set a specific memory address to be replaced by a redundant address. Fig. 33 shows a DRAM device which showed logic failures on half a row. After visual analysis, the defect was found to be a resistive poly word line adjacent to laser repaired rows due to misaligned and overpowered laser repair.

Fig. 33. Misaligned and overpowered laser repair.

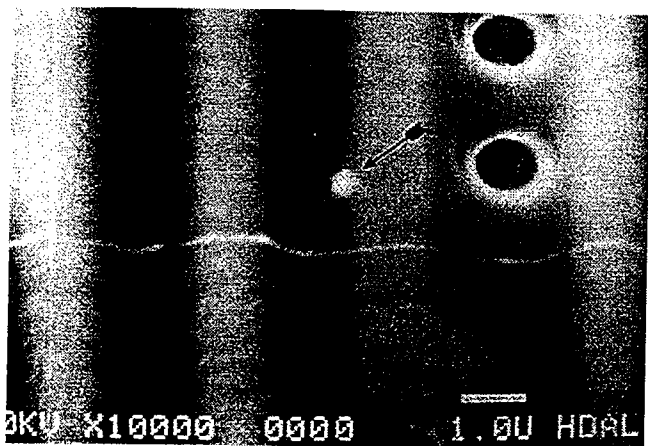
Silicided polysilicon lines have become popular in reducing the poly interconnect resistance. One problem associated with this technology involves titanium silicide (TiSi_2) and BPSG MLO. Fig. 34 shows a silicide extrusion was formed during the BPSG high temperature reflow and densification process. Although the defect appears to be silicide related, the root cause was primarily the MLO processing.

Fig. 34. Titanium silicide extruding from multilevel oxide layer, causing a short from the poly layer to the above metal line.

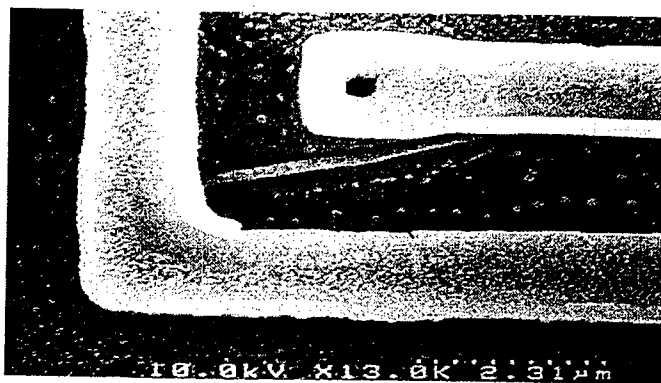
Fig. 35. Metal Filament which has broken off of the bottom metal line to short the two lines together.

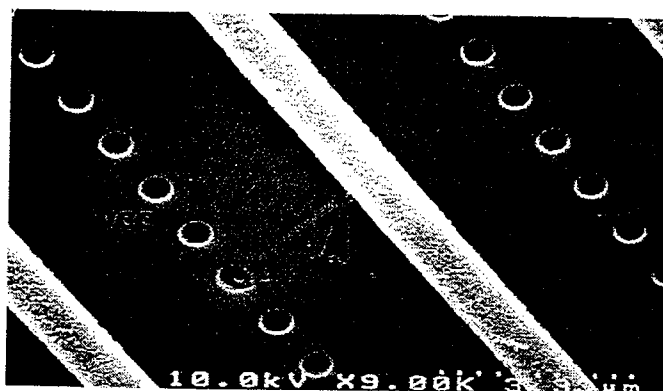
Fig. 36. Poly melt Filament resulting in a short.

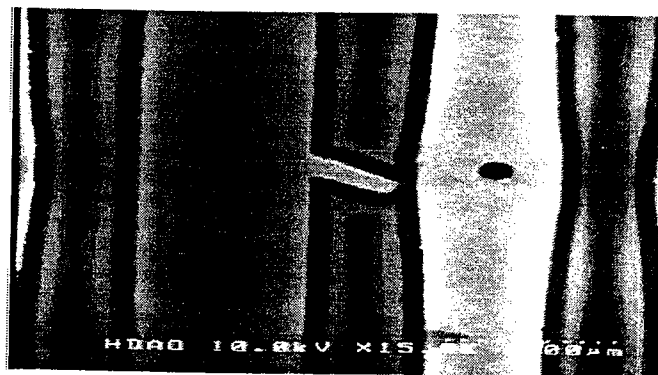
Fig. 37. Metal patterning defect causing a leakage/short to the adjacent failing column.

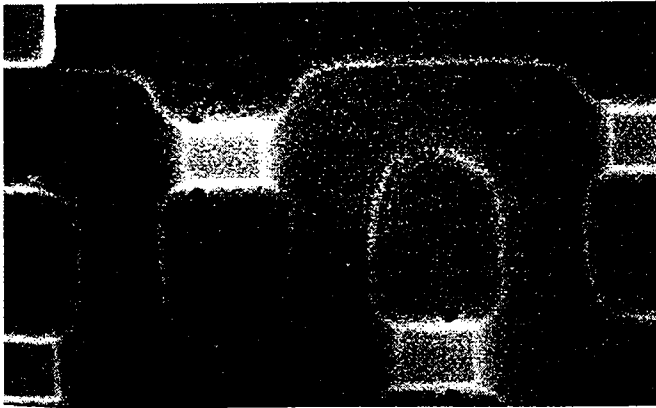
The example in Fig. 38 shows implant related dislocations at the gate region of P-channel transistors. Fig. 39 is a transmission electron microscope (TEM) cross section of a the failure, showing a loop dislocation in the silicon from source to drain under the channel region.

Fig. 38. Silicon dislocation.

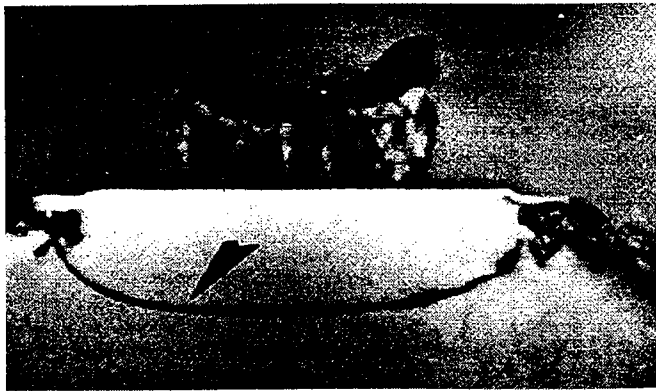
Fig. 39. TEM cross section of Fig. 38.

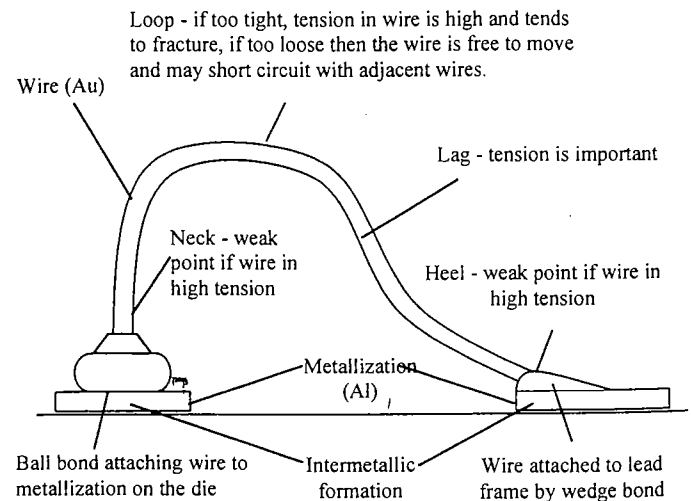
Bond wire failures. Figure 40 gives a pictorial view of the failure mechanisms that are associated with the bonding process. Several possible failures can be observed in the diagram. First of all, one must consider the formation of intermetallics at the Al pad/Au wire interface. Some amount of alloying is necessary at this interface to form a good contact, but excessive alloying may cause bond failure. Kirkendall voiding may also be present, where voids within the metals have migrated until merging together at the bond interface [1].

Fig. 40. Reliability issues concerning bonding process [1].

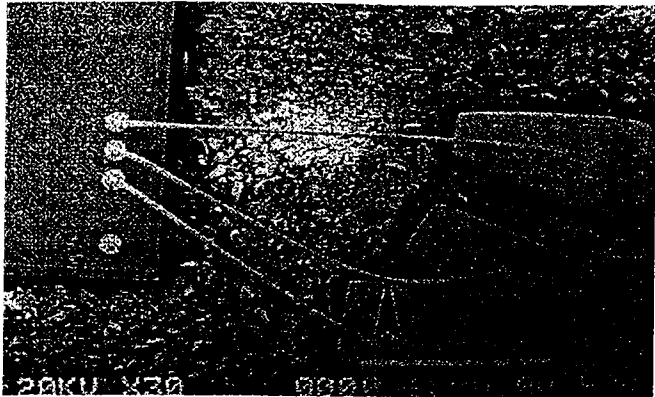
this can be seen in Fig. 41, which shows an example of pin leakage bond wires shorted to adjacent lead frame post. The root cause of this failure was determined to be a bonding machine tension feed failure. If the tension is too high, then the stress at the interfaces can lead to fracturing and opens. Examples of this can be seen in Figures 42 and 43.

Fig. 41. Bond wires shorted to adjacent lead frame.

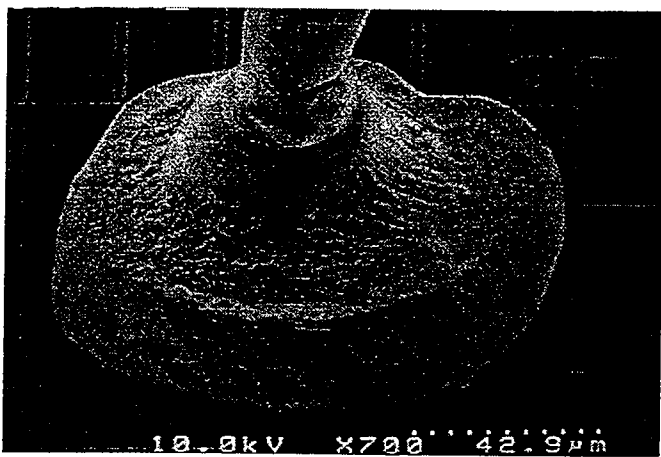
Fig. 42. Cracking at ball bond neck.

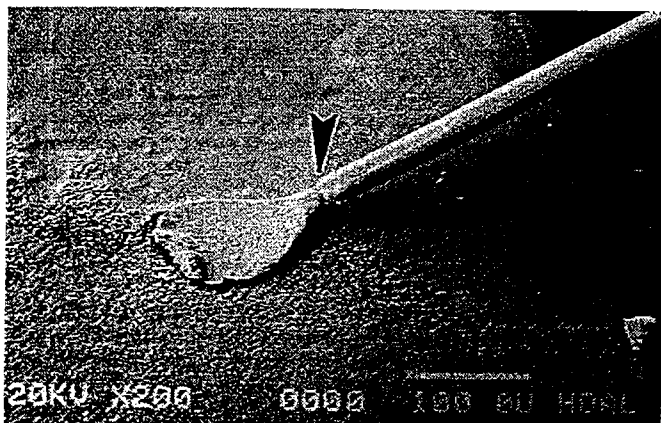
Fig. 43. Cracking at stitch bond.

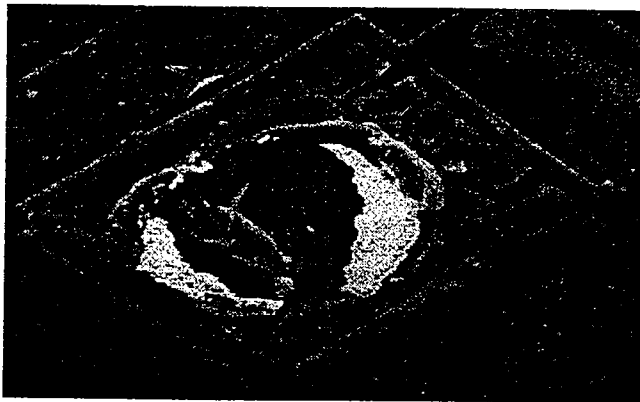
There are other concerns with the bonding process as well. Moisture has been found to aggravate the metal migration process by the influence of electrolysis. Contamination by impurities such as carbon at the base of the bond can also cause voiding and lead to ball bond lifting. Contamination from chlorine and other impurities can lead to corrosion, as seen in Fig. 44. In this case, corrosion has caused a discontinuity in the bond pad aluminum. EDX analysis detected chlorine at the bond pad. Thus, the root cause of the failure was determined to be corrosion caused by moisture ingress and chlorine contamination.

Fig. 44. Corrosion of bond pad due to chlorine presence.

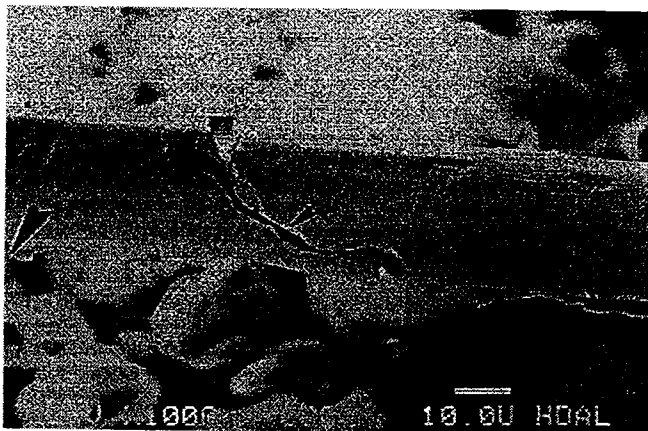
Fractures within the bond wire itself can also occur. Fig. 45 shows a fractured bond wire at Vcc associated with thermally degraded mold compound. This failure was most likely caused by electrical overstress.

Fig. 45. Fractured bond wire due to EOS

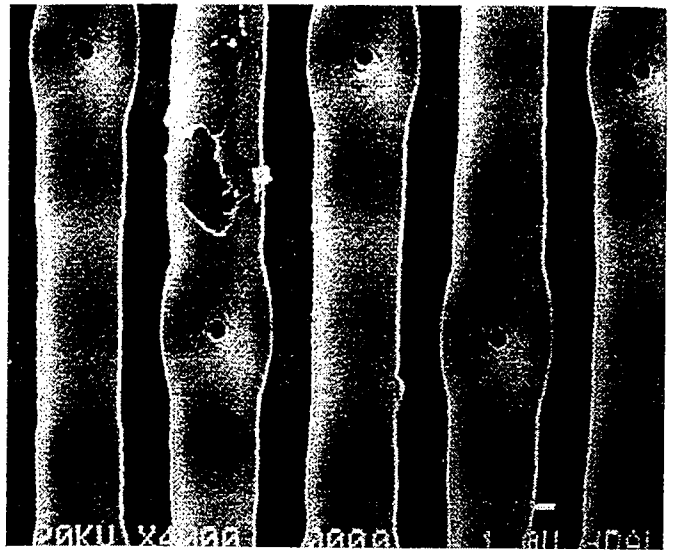
Fig. 48 shows an example of mold compound filler induced PO damage. Analysis involving a mechanical decapsulation confirmed a protruding filler particle. Thus, the root cause was determined to be mold compound filler induced PO damage. Fig. 49 highlights some of the key failure mechanisms related to PO damage.

Fig. 48. Mold compound filler induced PO damage.

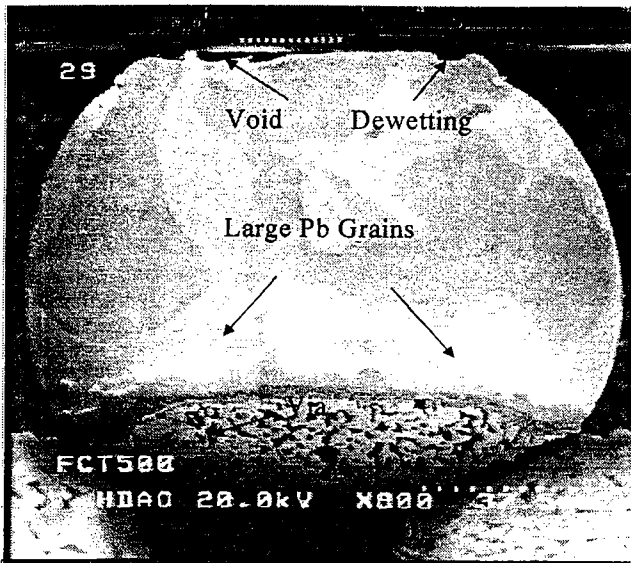
Proper package related fail mechanism identification for flip chip devices typically involves a die pull, die shear or a traditional cross sectioning of the interfaces within the device. One of the more compelling reasons for performing the cross section is the ability to examine the metallurgical surfaces within the bump. Of particular interest is the consistency of the Sn:Pb bump metallurgy, including the Pb grain size within the bump. Fig. 50 shows an SEM cross sectional image of a bump failing continuity testing. From the cross section, two major anomalies were noted. The first anomaly was the void and possible interface dewetting between the bump and the die interface. The second anomaly was a large Pb band shown at the bottom of the bump in Fig. 50. The Pb band has a tendency to be located near the via, which is the path of the current flow. Due to large amounts of current flowing through the via, the location near it tends to be heated the most, leading to large Pb grain formation at this location. Subsequent curve trace analysis of the bump to the die revealed lack of continuity between the bump and the die, which corroborated our observations.

Fig. 50. SEM cross section image of an open bump which separated due to thermal and electromigration effects.

The bump structure shown in Fig. 50 uses a thin layer of Ni/V to separate the Sn of the eutectic (Sn:Pb, 63:37) solder bump from the Al of the top level metal of the CMOS device. If the Sn diffuses through the Ni and reaches the Al interface the bond will be broken. It has been found that this diffusion process is aggravated by the influence of high temperature and hence, the amount of diffusion is a good indicator of the age of the device. The grain size of the Pb grains within the solder bumps are also good indicators of device age. Fig. 51 shows a cross section of a bump which has undergone tests involving high temperature conditions. The relatively large Pb grain sizes are noteworthy in this case.

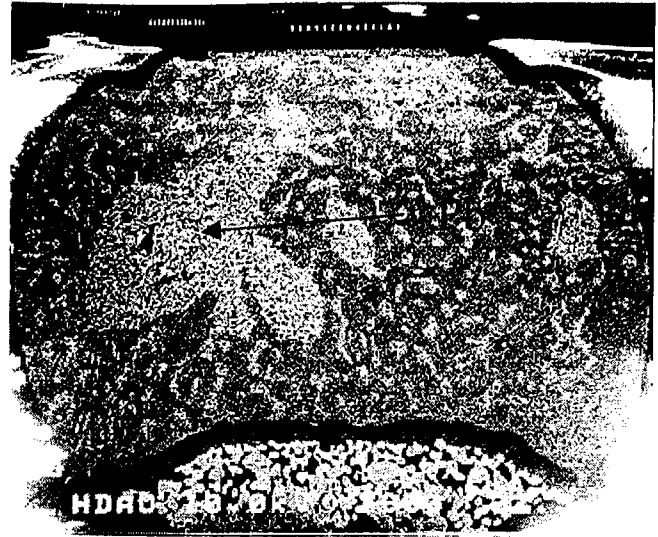
Fig. 51. Cross-sectional SEM micrograph of a bump after high temperature assembly, showing Sn and Pb grain sizes.

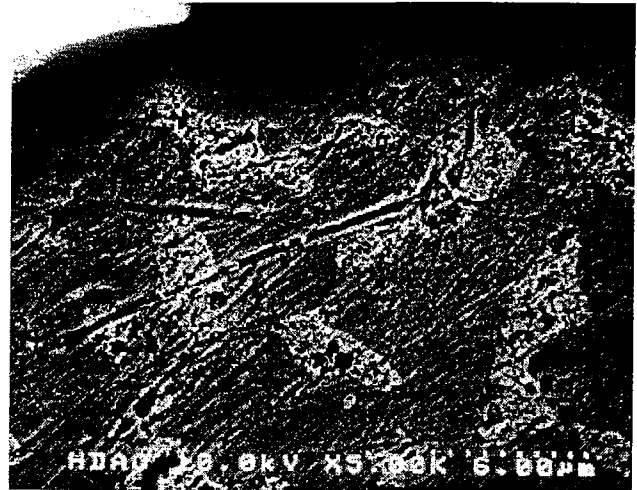
Fig. 52. SEM micrograph showing the intermetallic formation after high temperature assembly.

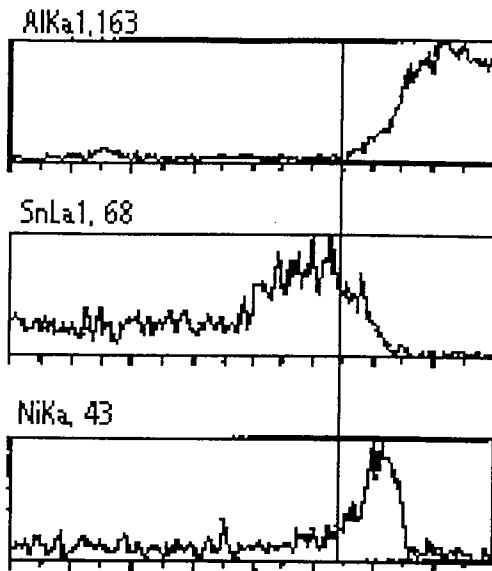
The extent of diffusion can also be determined by an EDX analysis of the bump, which reveals the amount of various elements at any point. Fig. 53 is an EDX linescan of the intermetallic formation seen in Fig. 52. As can be seen with respect to the reference line drawn across the linescans, Sn has already started to diffuse into the Ni during the assembly process. Any further heating of the bump will eventually cause failure.

Fig. 53. EDX analysis showing the diffusion of Sn into the Ni, as indicated by the overlap of the elemental graphs

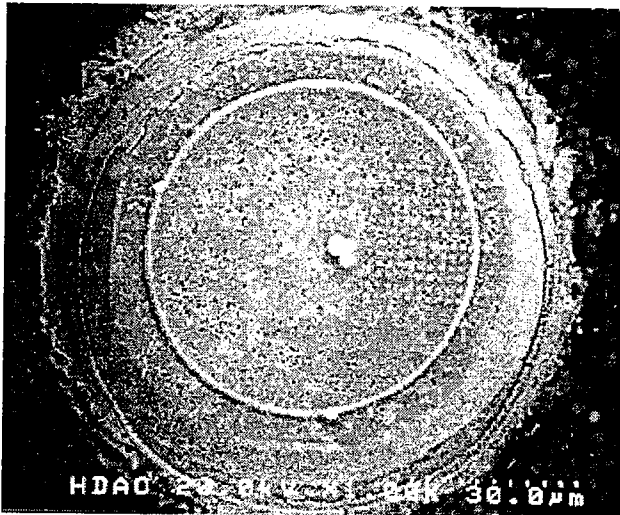
Fig. 54. SEM micrograph of a resistive bump. The bump de-bonded from the Al bond pad.

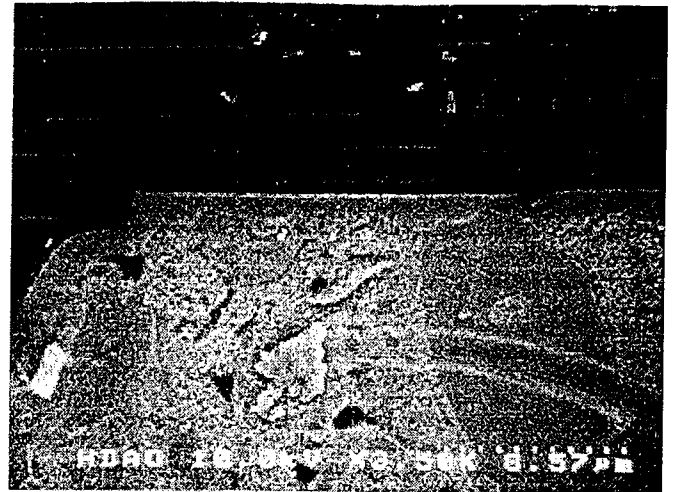
Fig. 55 shows a failure occurring due to the separation of the solder bump to metal five interface. The failure mechanism determined to be the diffusion of nickel into the

Fig. 55. De-bonding of bump from metal five interface.

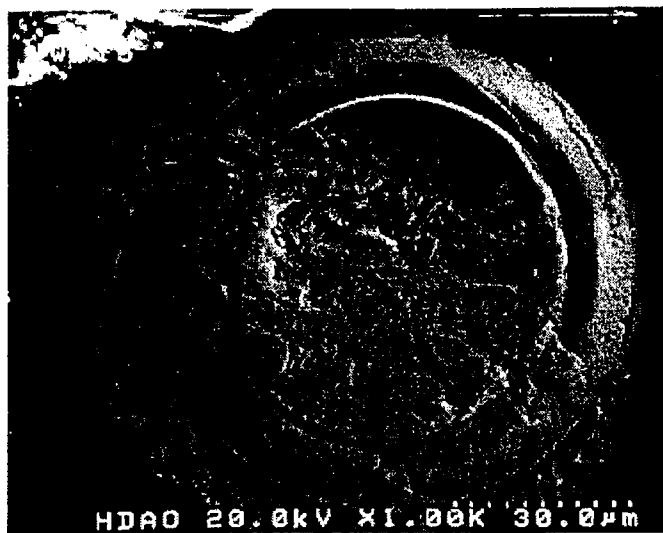
Fig. 57. SEM photograph of a failing bump, which was most likely melted during HTOL testing.

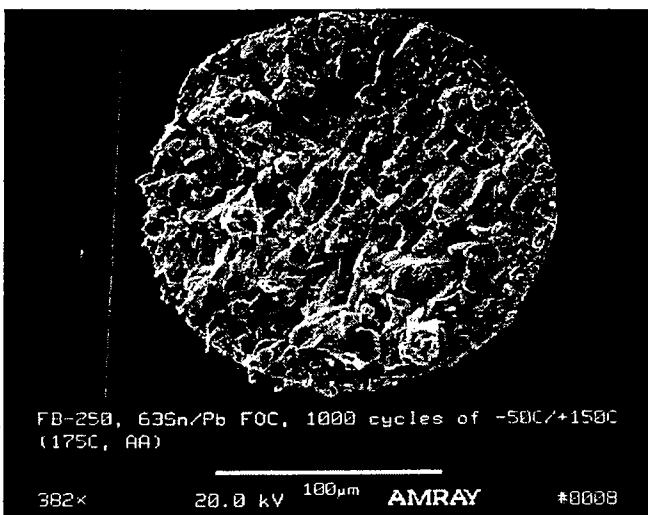
Fig. 59. Cross sectional view of bump in previous image.

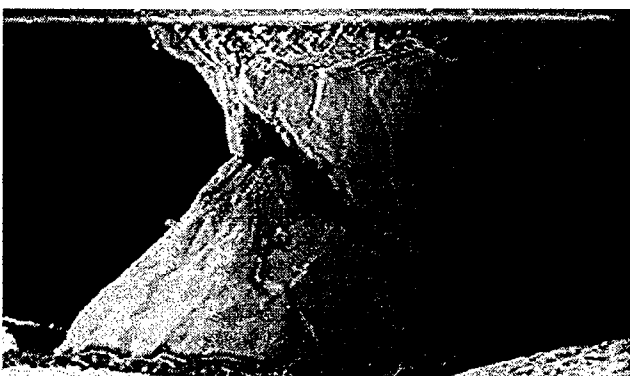
Fig. 60. Example of bump solder creep showing the two interfaces within the device separating from one another.

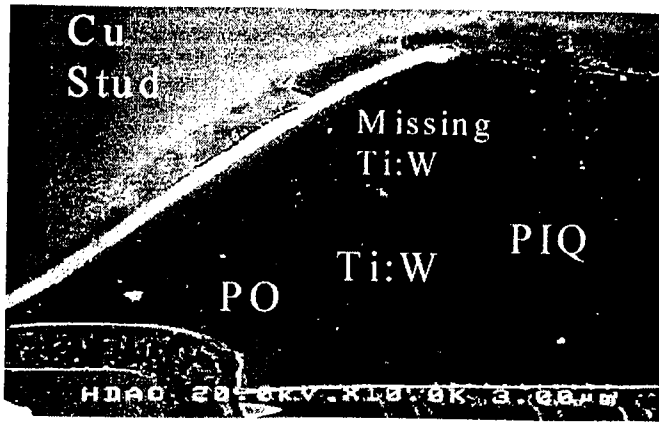
Fig. 61. Image shows lack of Ti:W metal near the cracked area which should extend out through it.

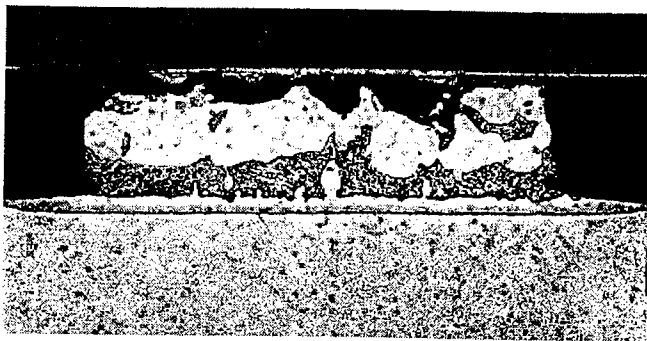
Fig. 62. Effects of the high electric field on the metallurgy within the bump. The image shows the positive node of a bump exhibiting signs of electro-thermal migration.

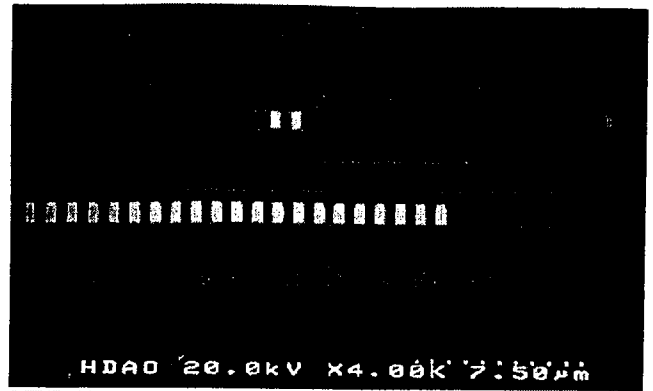
Fig. 64. ILO cracking due to thermo-mechanical package stress at the bump.

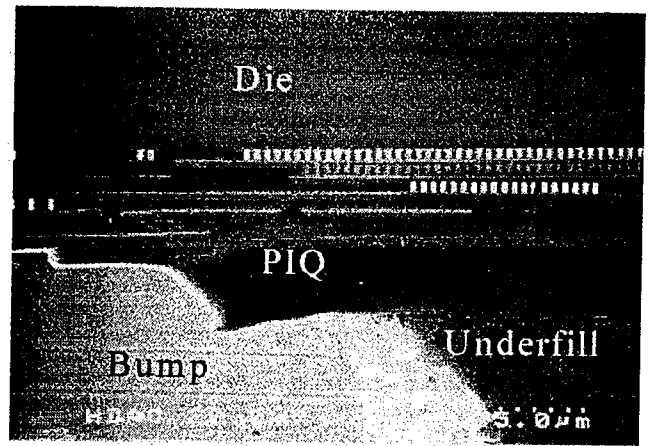
Fig. 65. SEM cross section image of underfill to PIQ delamination due to thermo-mechanical package stress.

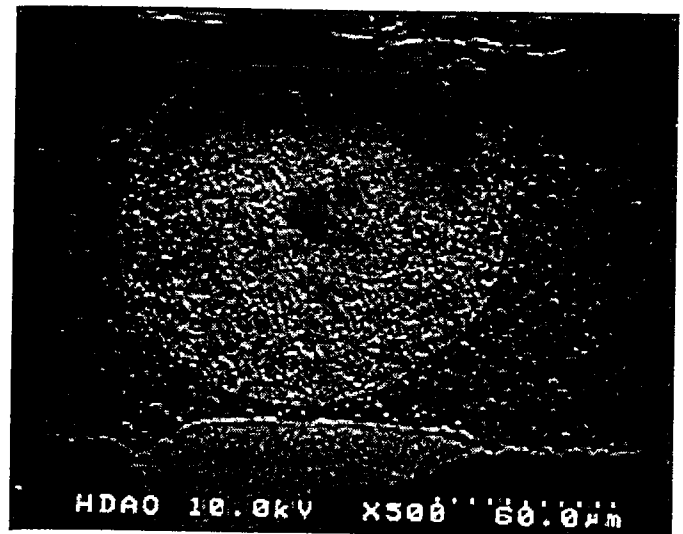
Fig. 66. Image showing a small bump due to the lack of solder plate.
